# Correlation Between Acupuncture Point Sensitivity and Front Hoof Thermography in Horses: A Preliminary Investigation

Shu Dai, Deng-Shan Shiau, Jose Zilberschtein, Huisheng Xie

### ABSTRACT

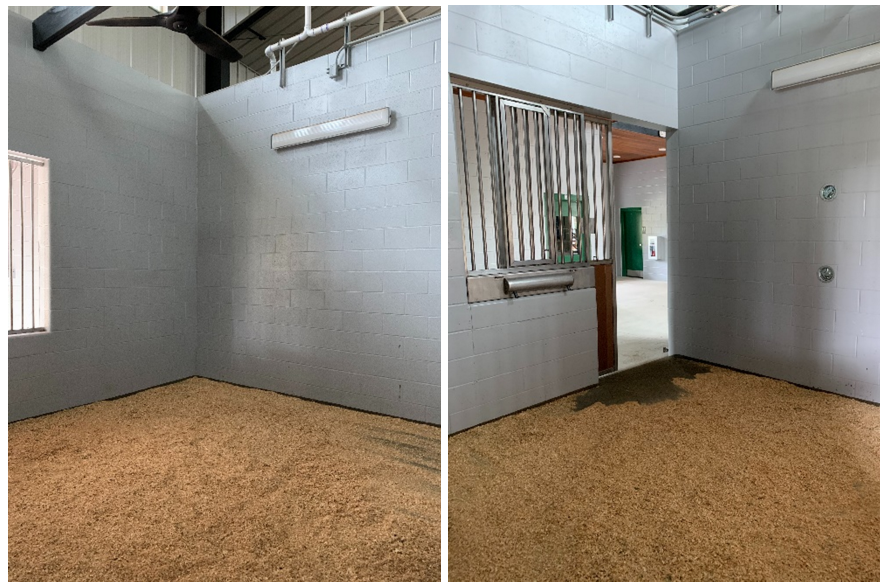
**Figure 1:** All thermal images were taken in a designated infrared thermography (IRT) imaging stall (pictures) with an ambient temperature ranging between 20 °C to 30 °C.

permission for study participation, each recruited horse was individually brought to the designated imaging stall (Figure 1). The front hooves were then visually inspected for problems (e.g. wraps, topical hoof medications) and a potential study horse was eliminated from sampling if the problem was determined to interfere with accurate hoof imaging. The horse was then allowed to rest for at least 20 minutes to acclimatize to the thermographic imaging environment.<sup>22</sup> This was followed by checking the rectal temperature of a horse to verify a body temperature less than 101 °F (normal equine range 36.0 °C-38.0 °C/ 96.8 °F-100.4 °F).<sup>23</sup> Hoof imaging for all study horses was then performed with a portable high-resolution infrared camera<sup>a</sup> (Table 1). The experimental protocol for all procedures in the study (equipment, environment, imaging technique, image analysis) were performed in a standardized manner as described in this section. The camera was calibrated prior to use by a company representative<sup>a</sup> with expertise in the equipment to be used in the study investigation.

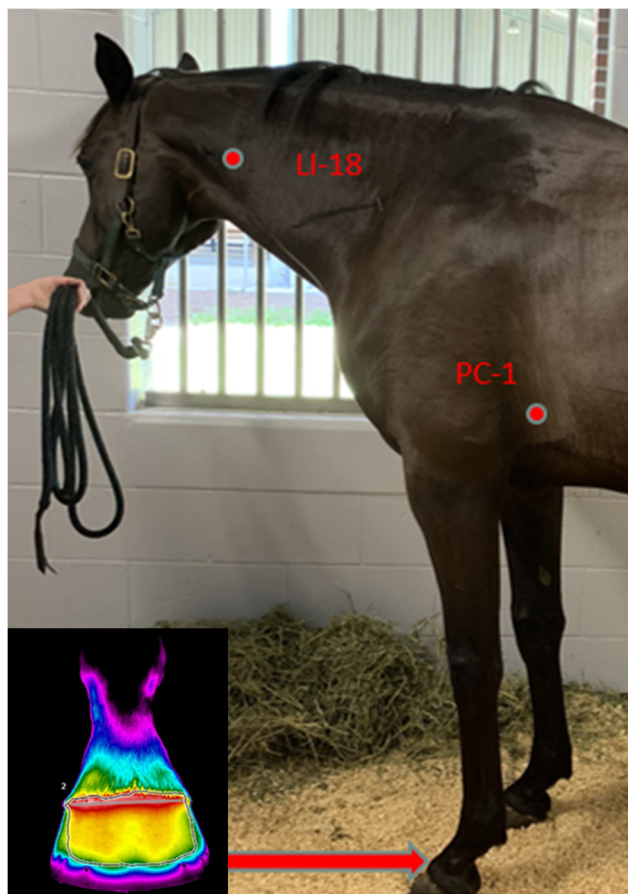
**Figure 4:** Locations of LI-18 and PC-1; the acupoint LI-18 is located at the depression just above the jugular groove, along the line of the ventral mandible with the head extended; PC-1 is located at the depression, medial to the point of the elbow and in the fifth intercostal space. The long red arrow at the bottom of the picture indicates the ROI for thermal imaging (dorsal surface of the hoof).

Immediately after the thermo-imaging, APS was performed on LI-18 and PC-1 bilaterally to determine sensitivity/pain at each acupoint (Figure 4). This procedure was performed using an acupuncture needle guide tube (28 gauge, 2 inch) which was stroked firmly across the skin on a neutral area of the neck (base of mane) that does not have diagnostic acupoints. This preliminary step both familiarized the horse with contact by the tool and allowed the clinician to gauge the amount of pressure to exert on the skin of that individual. The pressure was sufficient to be easily felt by the horse on the skin and underlying musculature but be well-tolerated by that individual. At LI-18, the strokes of APS were in a cranial-to-caudal direction, but at PC-1, the APS strokes were in a dorsal-to-ventral direction. The scanning stroke was repeated 5 times. To be assigned a sensitivity grade, at least 4 of 5 strokes had to have a positive response. Based on a horse's response (behavior change) to palpation at each acupoint, the sensitivity was graded on a scale from 1 to 5 (Table 2).<sup>5</sup> The veterinarian (CVA qualified) who performed the APS was blinded to each horse's physical condition/clinical diagnosis and thermal imaging results. The same person performed all APS evaluations on study horses to reduce between-subject variability. The APS and horse's response were recorded during examinations for later evaluation.
